Use of sensors, GIS, & detailed farm diaries for engagement, extension & education in the Waipa

Monitoring the Moakurarua

The Moakurarua River has been identified as a Priority 1 catchment within the recently released Waikato Region Healthy Rivers Plan Change 1.

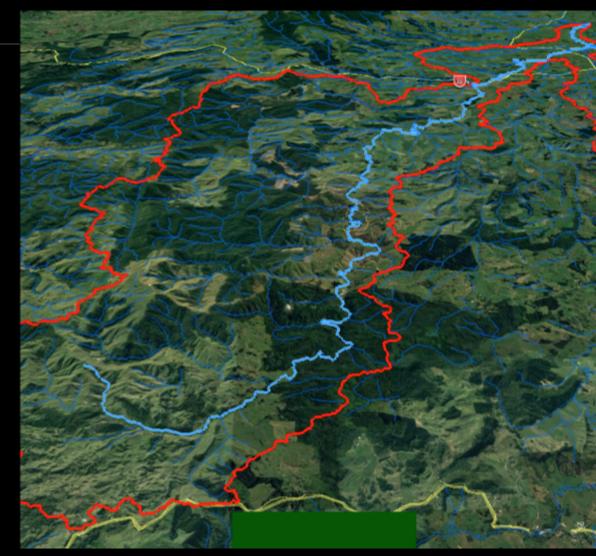
Right: Overview of the Moakurarua River catchment and tributaries

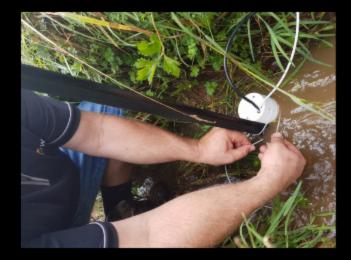
Above: Time-lapse camera in situ

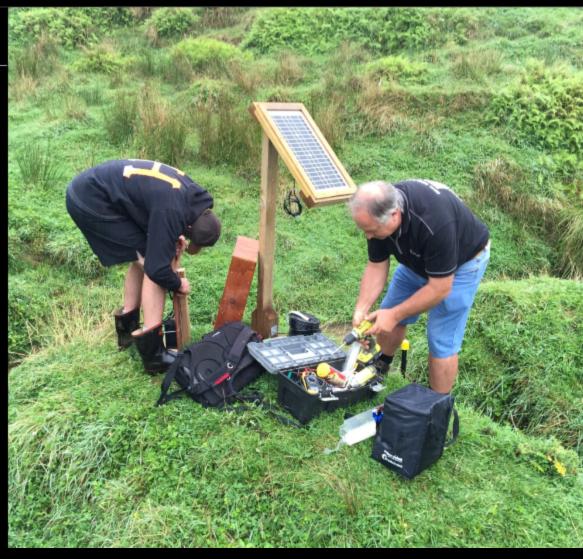
Right: Equipment install and sensor site 1

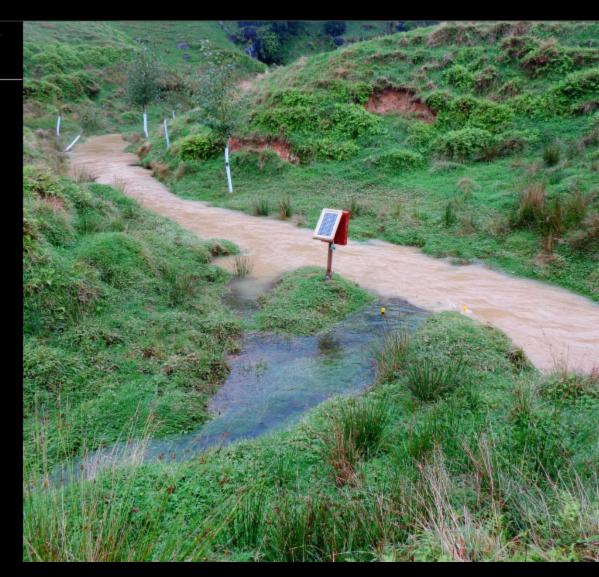
Right: Flooding after Ex-Tropical Cyclone Debbie, April 2017. Note the the turbidity of the main stream is caused by two slips originating in the native bush at the top of this sub-catchment.
