# Dynamic Catchment Generator

**Subodh Dhakal**  
**Senior Spatial Data Specialist**  
**Abley (on Secondment role at NCTIR)**

# NCTIR - North Canterbury Transport Infrastructure Recovery

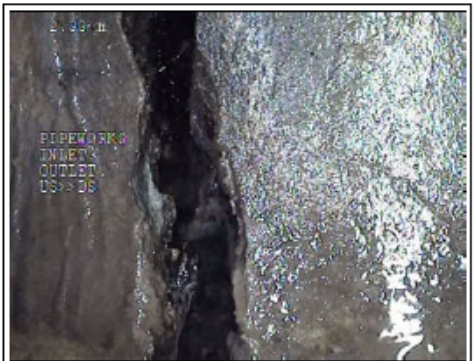
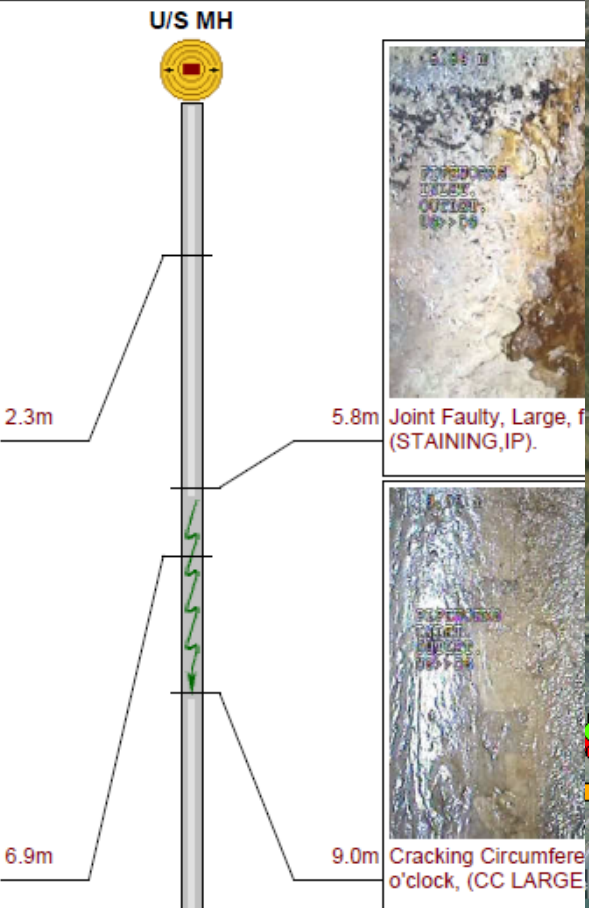
Cracking Circumferential, Large, from 12 to 12 o'clock, (CC,IP,OT).

Joint Faulty, Large, f (STAINING,IP).

Cracking Circumferential, Large, from 12 to 12 o'clock, (CC LARGE).

**Inspection Status: Damaged**

The Culvert with drainage id: 84538 made from **Concrete** has been identified as **Damaged**. For the full PDF report of the culverts please [click here](#).

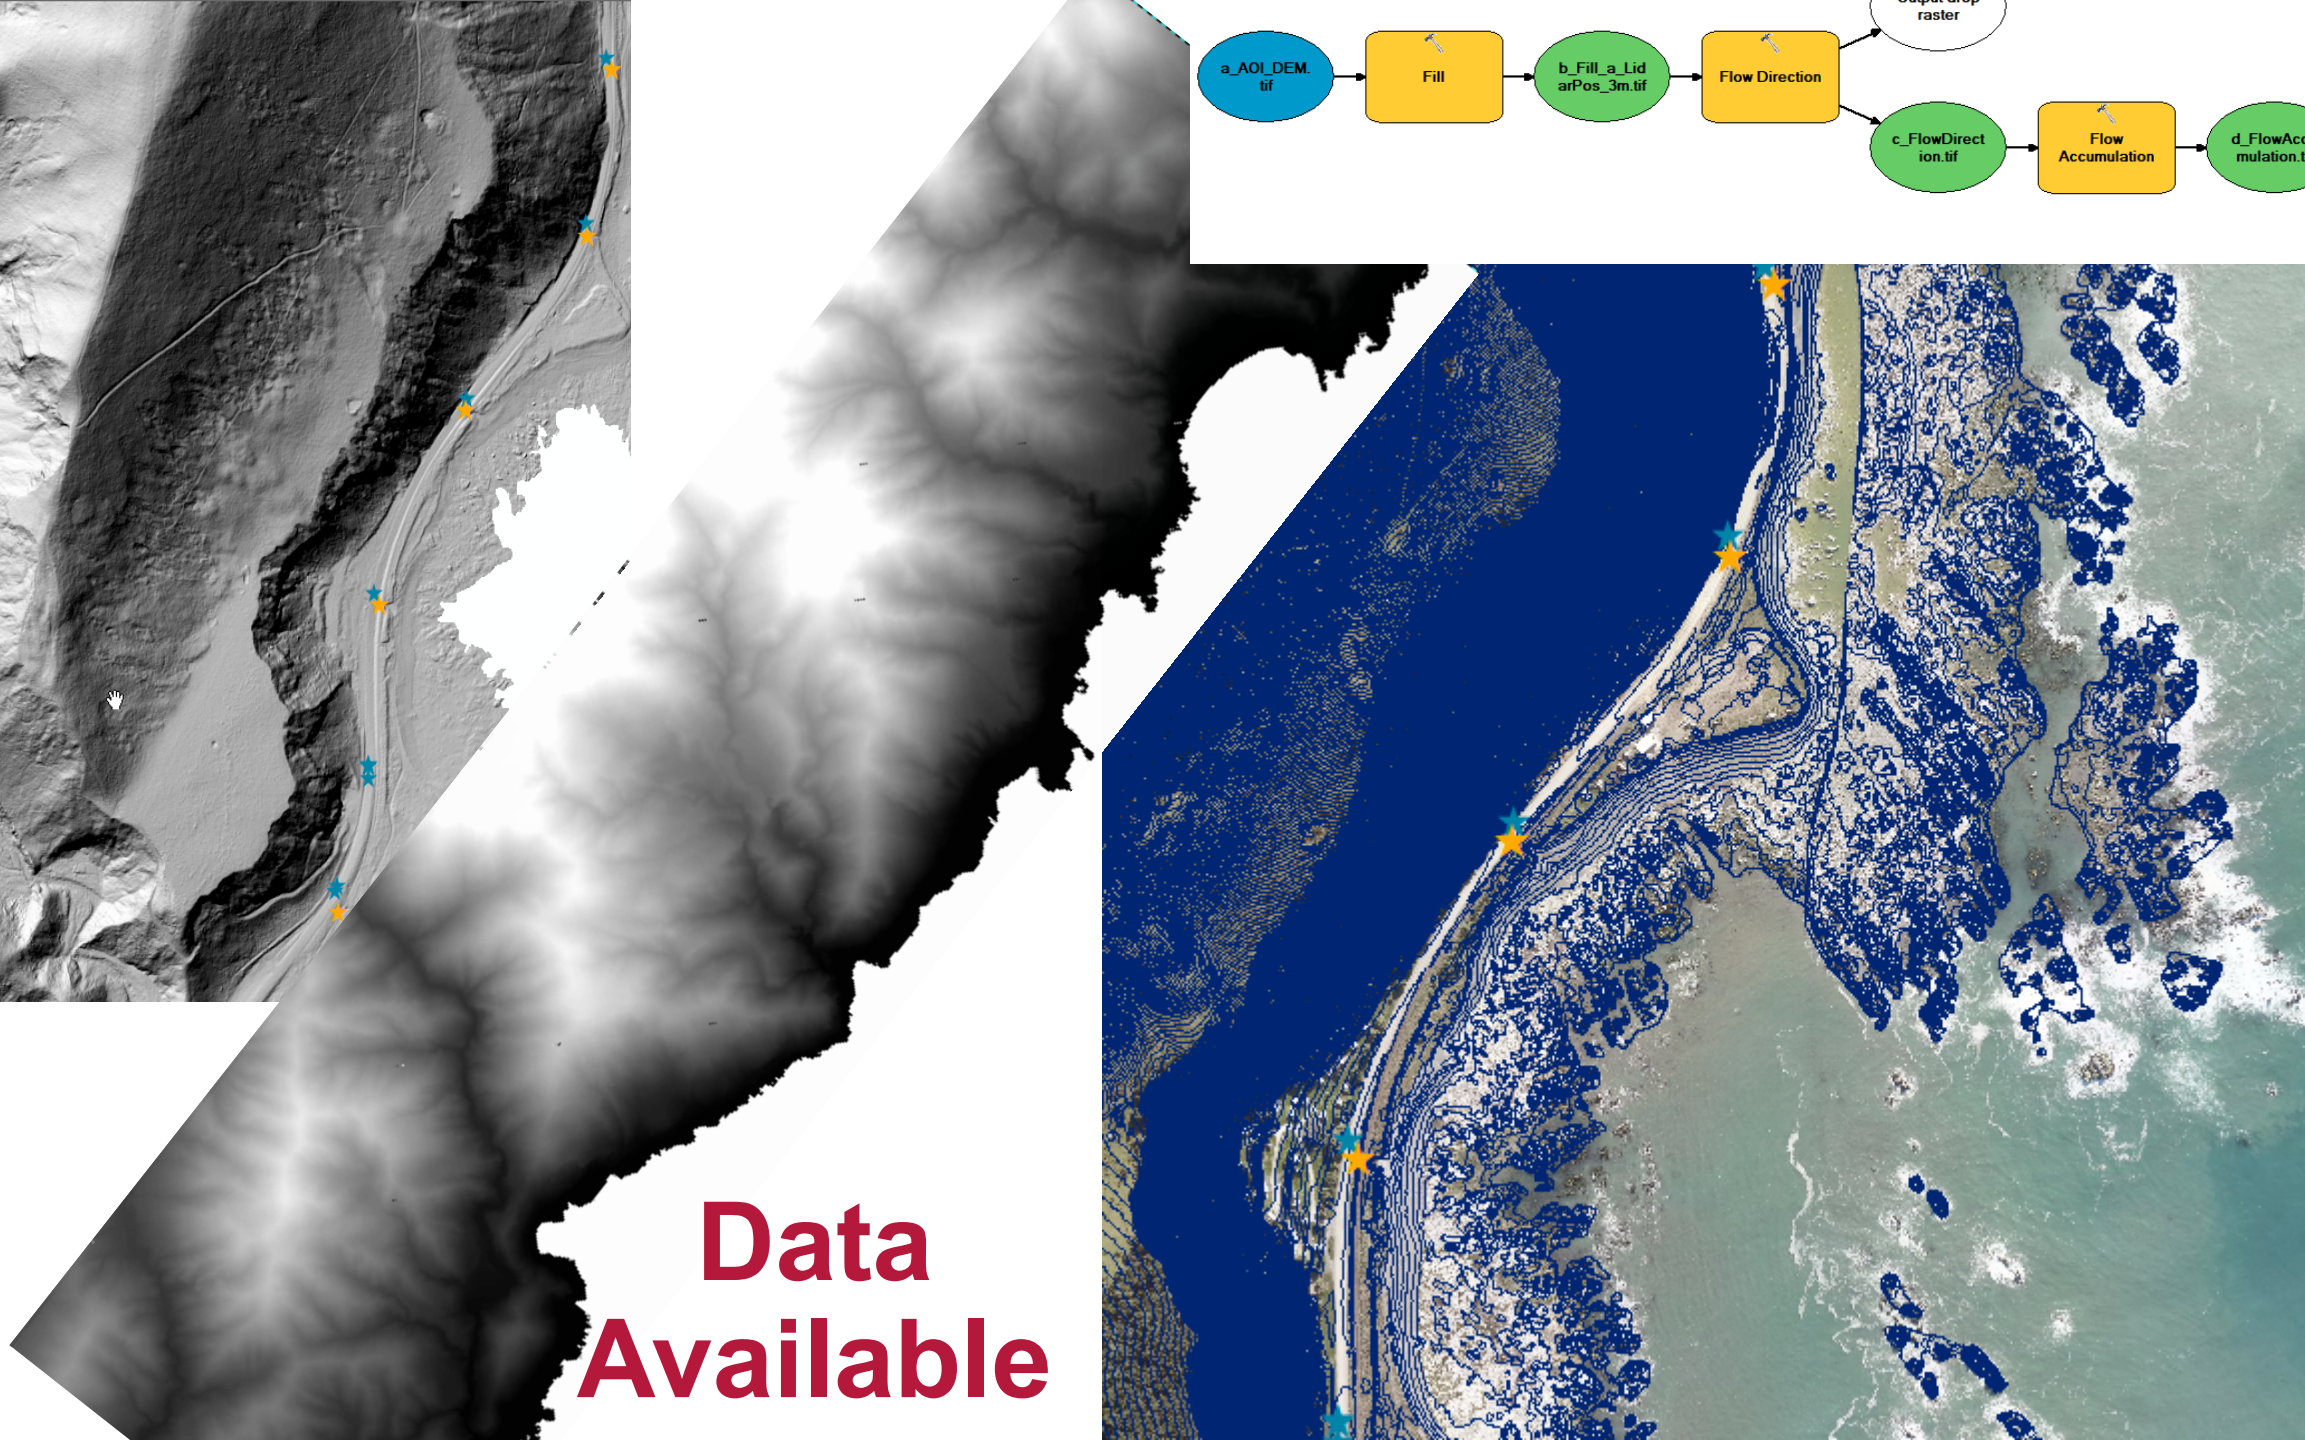
**Data  
Available**

**Very random results.....due to flat surface**

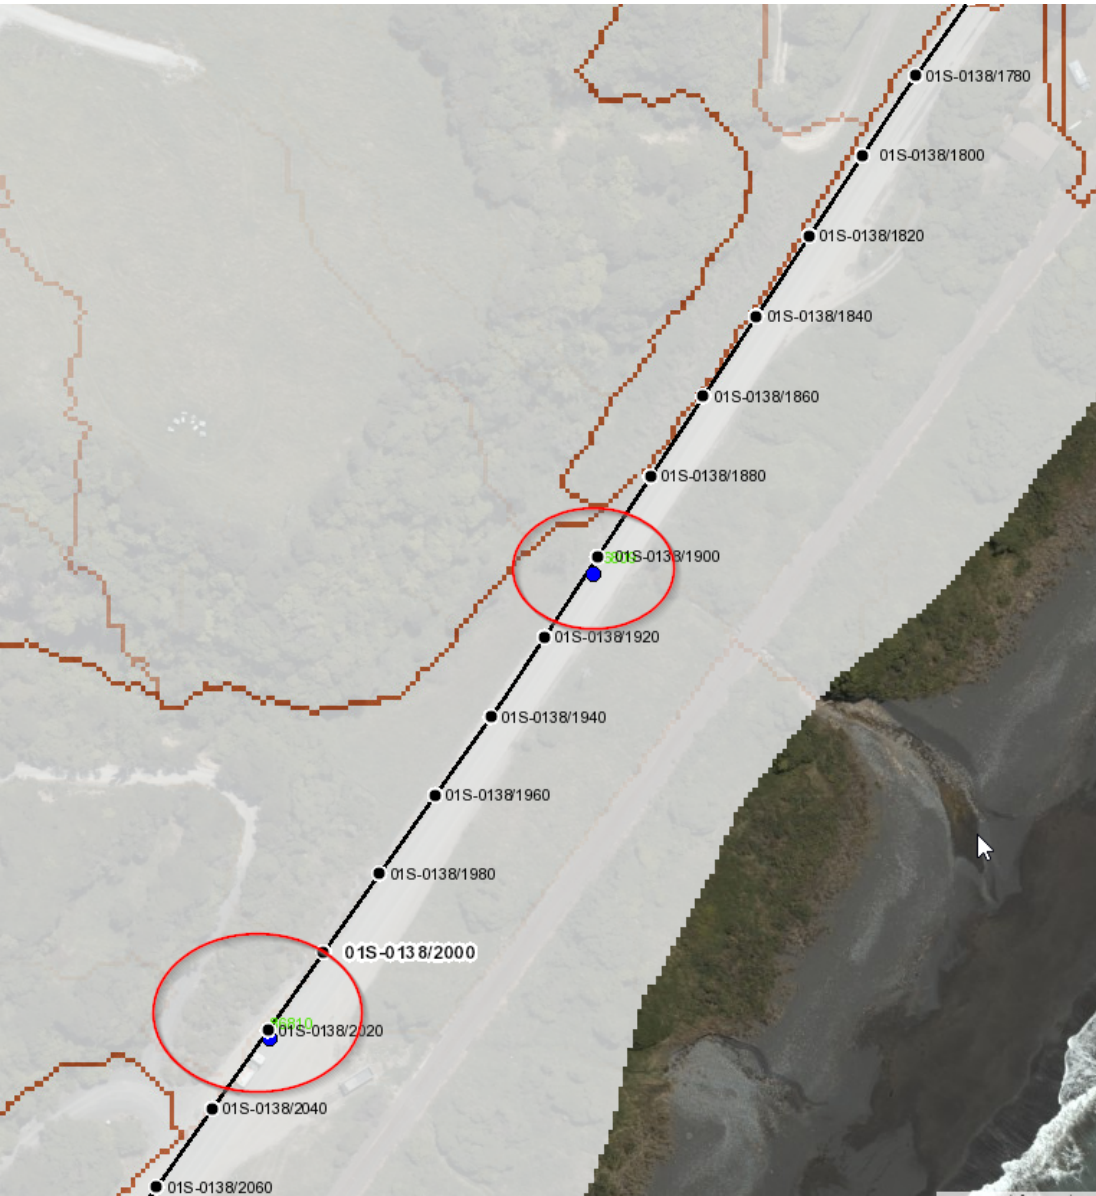
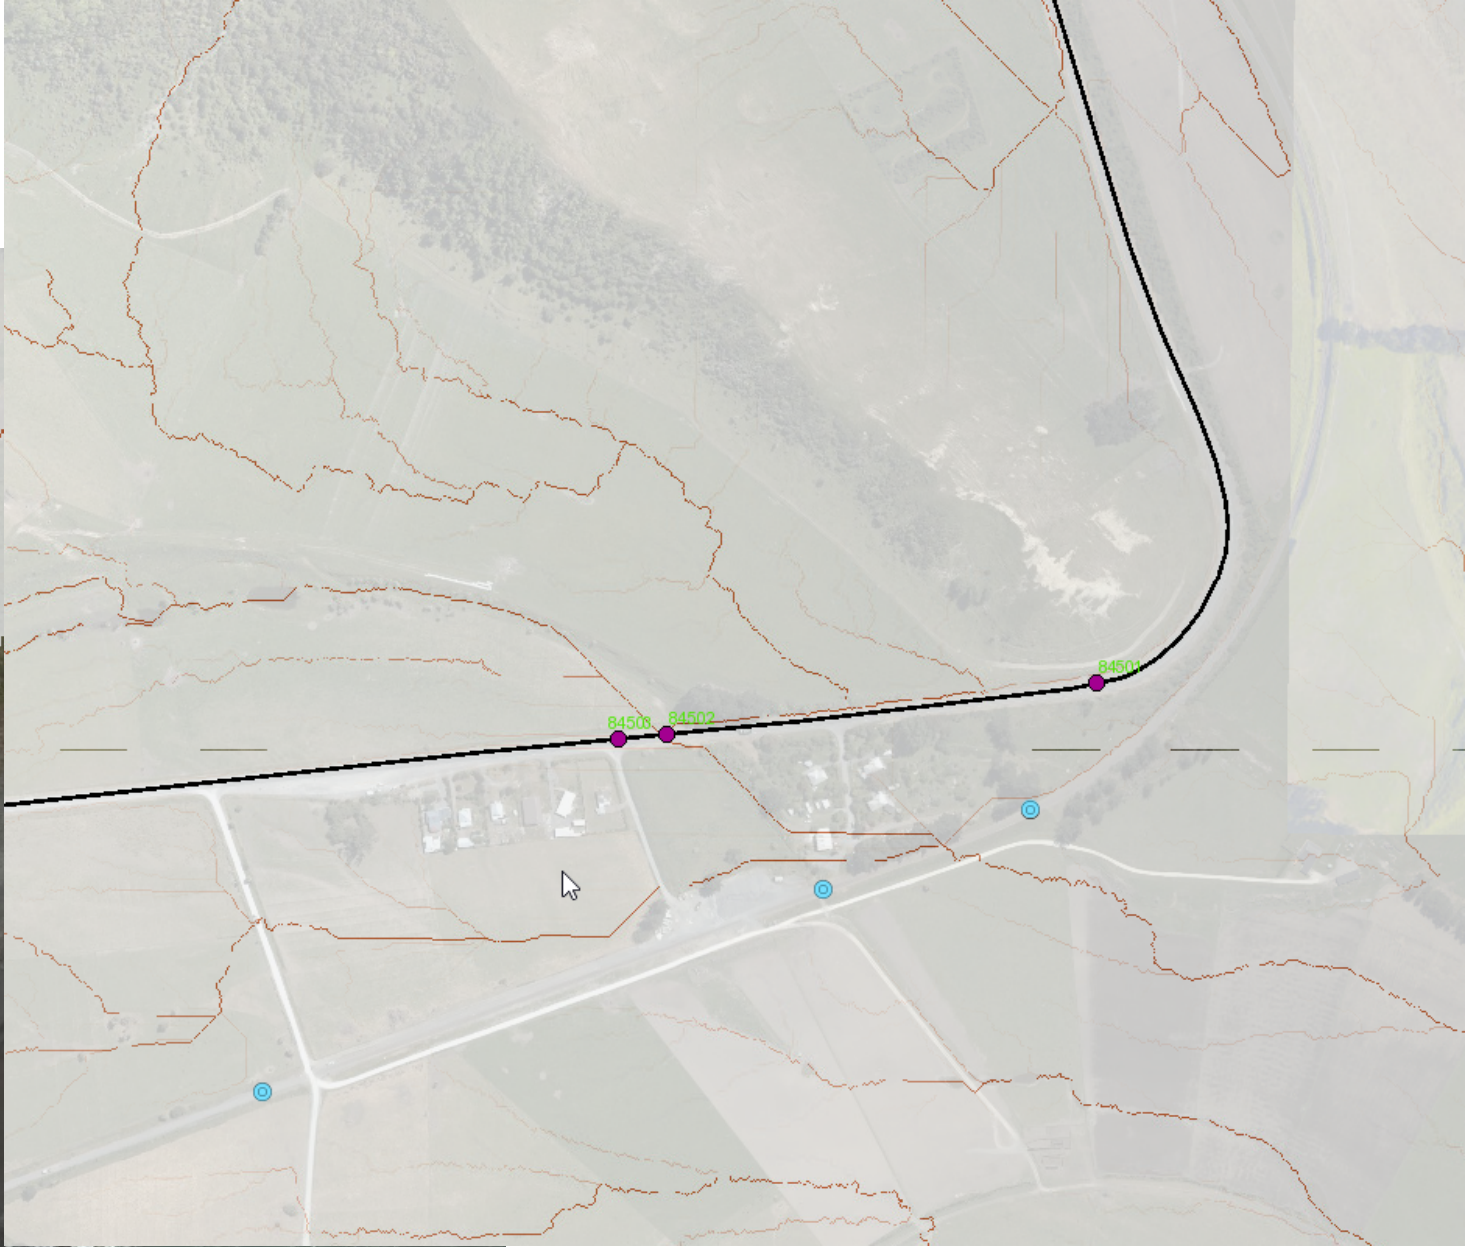
# Flow Accumulation Vs Existing Culvert Location

Batch Processing to generate  
catchment didn't worked 😞

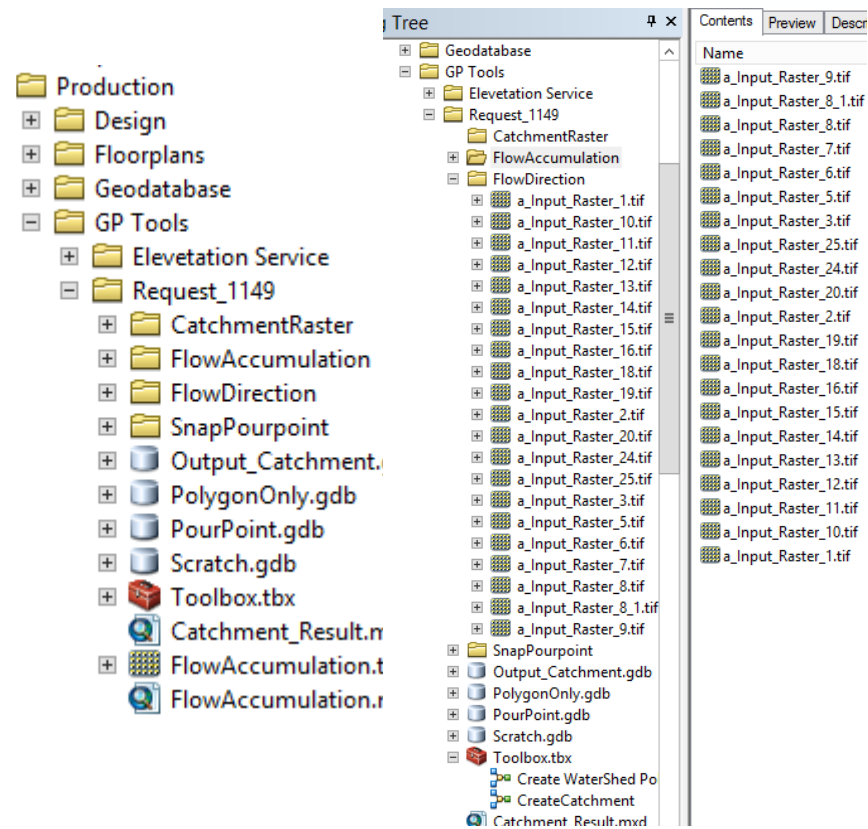
# The process

- Generate Flow direction & Flow Accumulation raster
- Divide the project area into several smaller
- Publish the workflow as GP service
- WAB GP widget...

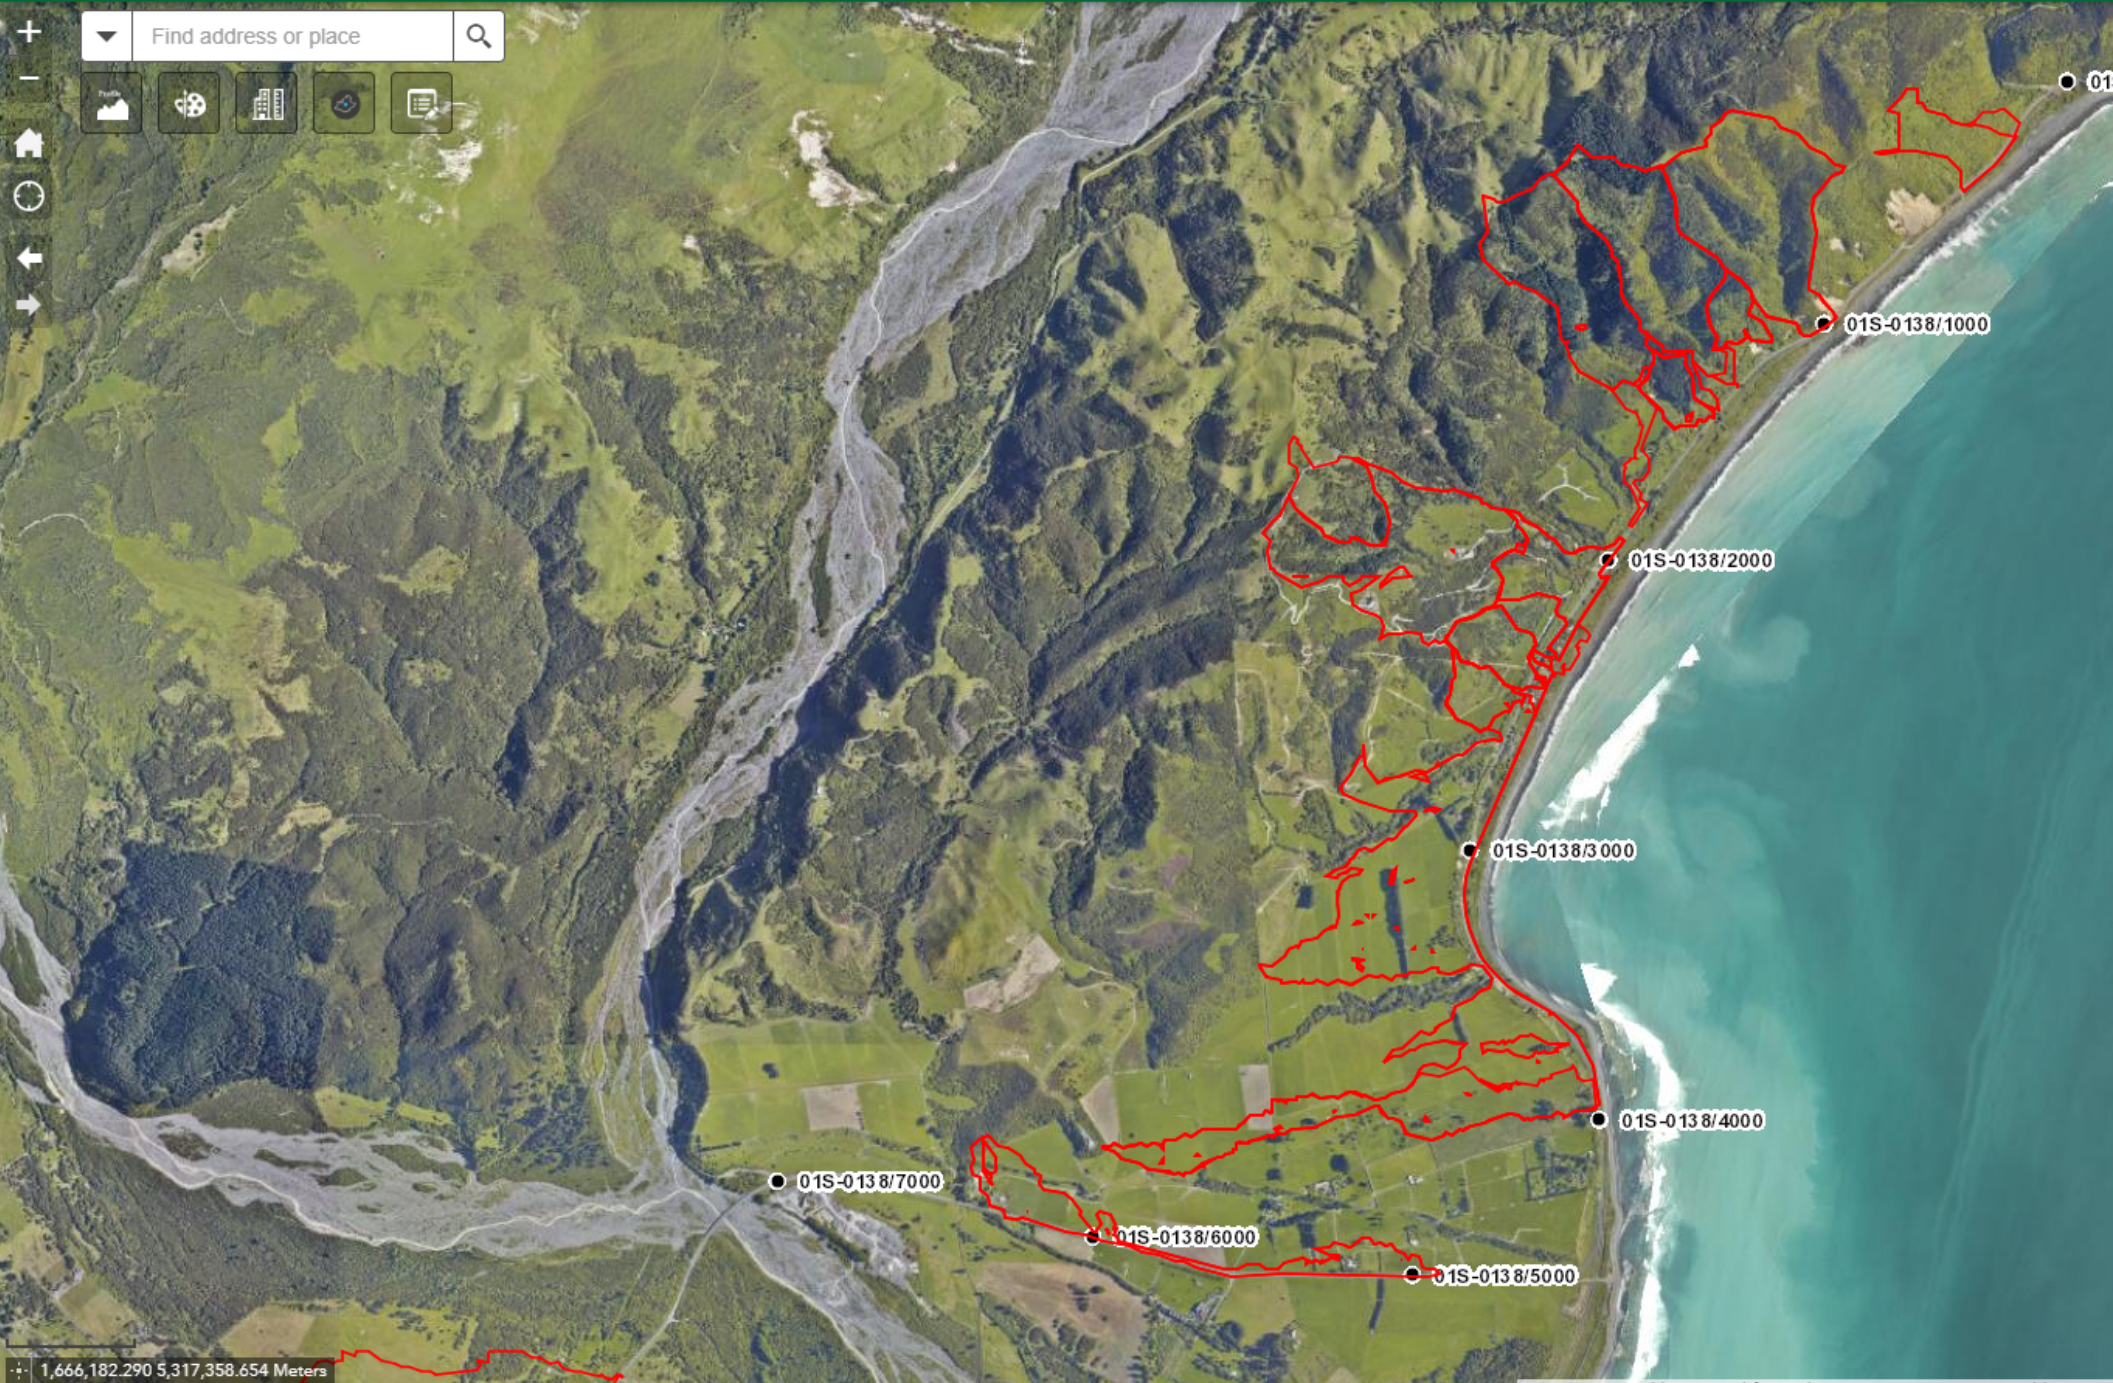
**Web Solutions:** Dynamically creating catchment on any specified pour point.

6km  
1,649,647.353 5,291,844.390 Meters

1,666,182.290 5,317,358.654 Meters
